**POWERFUL POLYMERS
PAINLESS PROCEDURES
RAPID RESULTS**

Water Treatment Plant Losing Two Million Gallons Per Day Due to Leaks

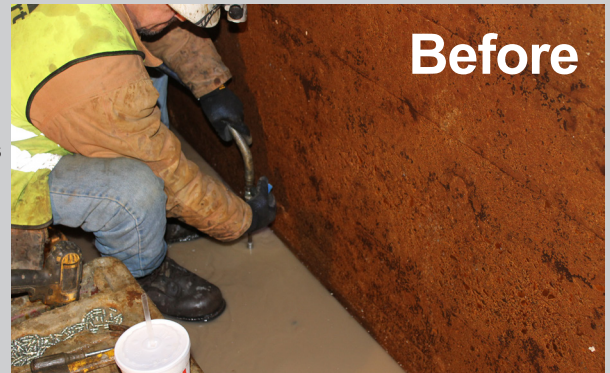
Before

On top of a hill northeast of Chattanooga, Tennessee sits a clearwell that belongs to Eastside Utilities. Built in the 1940's on a former Army post, this clearwell consists of twin 2-million gallon tanks used for treating surface water to turn it into drinking water. The problem was that less than half of the water coming into the clearwells was making it out the other side. Although this water treatment plant has undergone several upgrades in its 70+ year lifespan, the ground beneath it has been subject to settling and consolidation. The tanks had shifted slightly and in doing so, loosened some of the joints and the water stops contained within. Measurements indicated that **the clearwells were losing 1,700 gallons per minute through various leaks**; well over 2-million gallons per day. A short drive downhill from the property revealed various gullies and small creeks created by water running down the hillside.

Due to the amount of water escaping, all of the joints around the perimeter walls were suspect as well as the roof support columns throughout each clearwell that penetrated through the floor. The contractor drilled holes to intersect the leaking joints around the perimeter of the clearwell and along all interior joints. Injection ports were installed and AP Seal 500 was pumped into each one to create an injected membrane within the joints and beneath the clearwell.

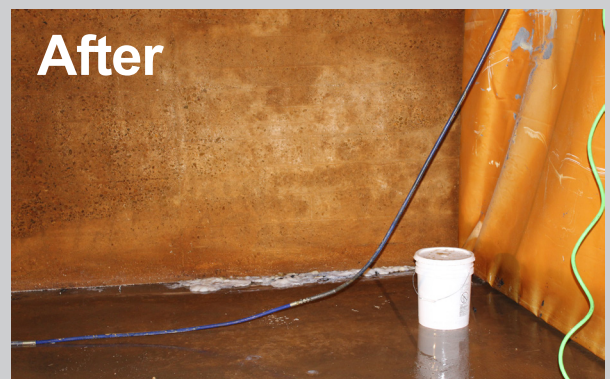
After three days of injection the work was done and the site was cleaned up. Monitoring after the AP Seal 500 was installed indicated that **the leak had been reduced from 1,700 gallons per minute to 10 gallons per minute**. The small number of remaining leaks were attributed to the many vintage valves and fittings that are still present at the plant.

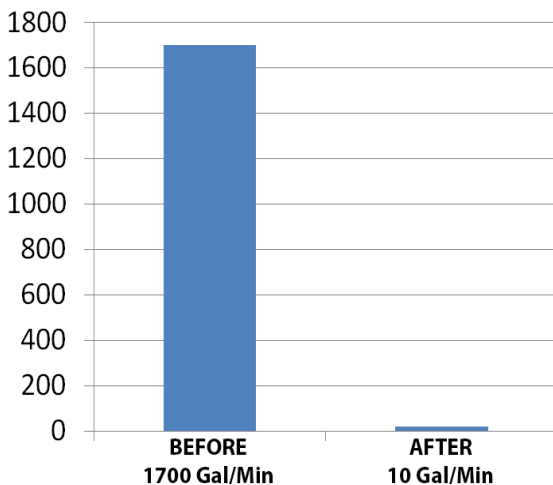
Water Leak - Gallons Per Minute

**99.4%
exfiltration
SEALED!**

Small number of remaining leaks due to vintage valves & fittings.
