## Massive Leak in Aquifer Shut Down

In the summer of 2017, a major water treatment plant contractor was working on a water treatment plant expansion in the Tampa area (the contractor wants details kept confidential). The massive new structure would extend 30' deep and would be supported by a series of piles installed down to bedrock. The contractor drove sheet pile in a rectangular configuration to create a coffer dam and excavated the soil down to a depth of 30' below grade. They set up dewatering pumps outside the perimeter of the box. During installation of the first test pile, the contractor perforated the aquifer causing a fracture. This was 30 feet below the bottom of the excavated coffer dam, a total of 60' below grade. Water poured into the excavation pit at an alarming rate estimated to be 500 gallons per minute. The excavation quickly became a large swimming pool and the project ground to a halt.

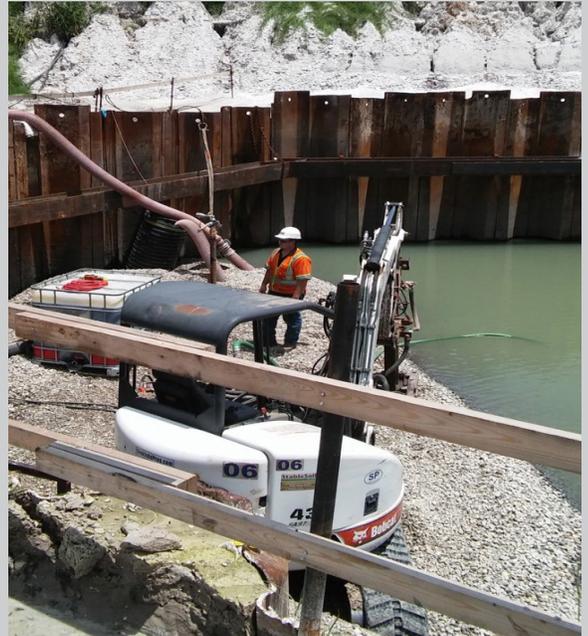
We figured we would have one good shot at getting this stopped. Huge pumps were brought in to empty out the water. At this point the sand was close to liquification and it presented a "quicksand" like safety hazard. The contractor built a platform out of gravel inside the coffer dam. The gravel platform served to add stable ground for the technicians and their equipment. The crane operator lowered a small drilling unit into the pit and a two-inch drill pipe was installed next to the test pile down to a depth of 31 feet.

Two 250-gallon totes of fully catalyzed AP Fill 700 were each connected to high volume pumps which were in turn connected to the pipe. An assembly of pipe fittings and valves connected the totes, pumps, and pipe together in an assembly that looked like an oil field "Christmas tree".

The object was to put as much polyurethane as possible down to the leak in the shortest time possible. Our theory was that the 30' of overburden would serve as a backstop for the rapidly reacting and expanding resin, forcing it to go into the fracture and ultimately sealing it off. The contractor pumped all 500 gallons down the drill pipe in less than 10 minutes. A third tote was lowered into place in case the first two didn't work.

After the first two totes were empty, the Project Manager turned off the dewatering pumps so that we could see if the water would resume rising in the coffer dam. As the minutes ticked by everyone began to breath easier. The water did not rise and the repair was a success saving the contractor and their customer a ton of money in potential redesign costs and lost time.
